Manhole Inspection Summary

Manhole # S21AA_018MH

Location Address: **918 ALLEY-MOSHER-LAFAYETTE**

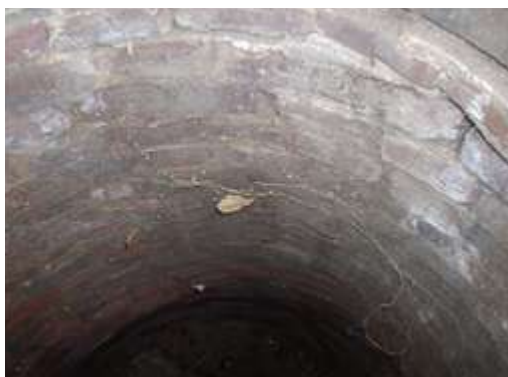
Defect 5

Condition: ☐ Sound ☐ Cracked ☒ **Root Intrusion** ☐ Loose Brick ☒ **Deteriorated**

ROOT INTRUSION OF THE CORBEL

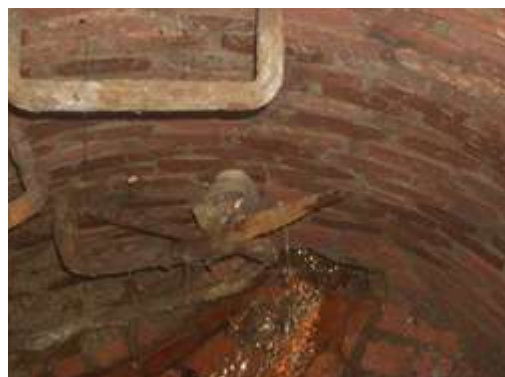
Defect 4

☒ **Evidence Of Surcharge** Depth: **2** (ft.) ☐ Active Surcharge Present

SURCHARGE EVIDENCE ON THE STEP

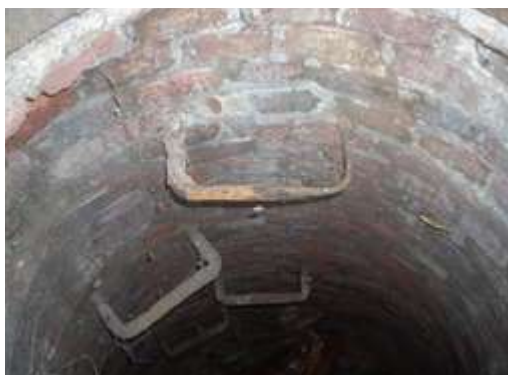
Defect 3

Count: **5** Missing: **0** ☒ **Corroded**

CORRODED STEPS

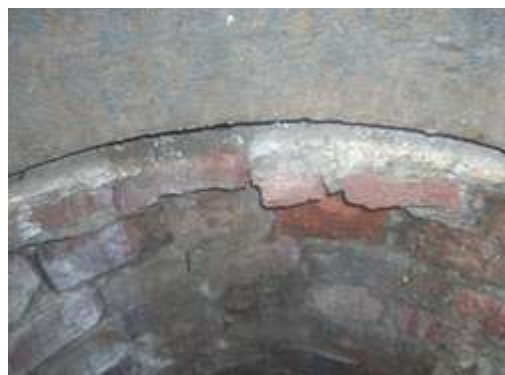
Defect 2

DETERIORATED CORBEL

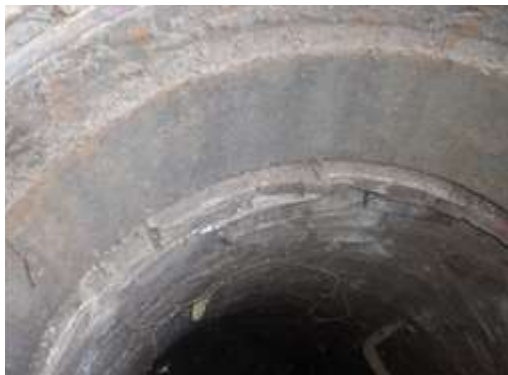
Defect 1

Offset: **1** (in.)

FRAME OFFSET

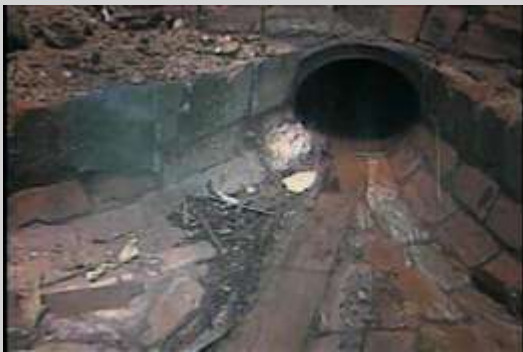
12 O'Clock Outflow

8 in. Circular Gravity Sewer
Pipe Out @ 12 O'Clock

Pipe Height: **7.2** (in.) Rod and Bar (Angled)
Pipe Material: **Clay** ☐ Pipe Lined
Invert Depth: **9.02** (ft.) Flow Characteristics: **Slow**
Deposits: ☒ None ☐ Mud ☐ Sludge ☐ Debris ☐ Grease
Silt Depth: (in.) Deposits Extent:
Infiltration: **None** Pipe Seal Cond: **Sound**

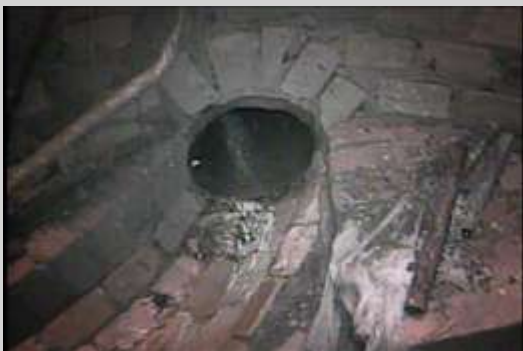
3 O'Clock Inflow

8 in. Circular Gravity Sewer
Pipe In @ 3 O'Clock

Pipe Height: **7.2** (in.) Rod and Bar (Angled)
Pipe Material: **Clay** ☐ Pipe Lined
Invert Depth: **8.60** (ft.) Flow Characteristics: **Slow**
Deposits: ☒ None ☐ Mud ☐ Sludge ☐ Debris ☐ Grease
Silt Depth: (in.) Deposits Extent:
Infiltration: **None** Pipe Seal Cond: **Sound**

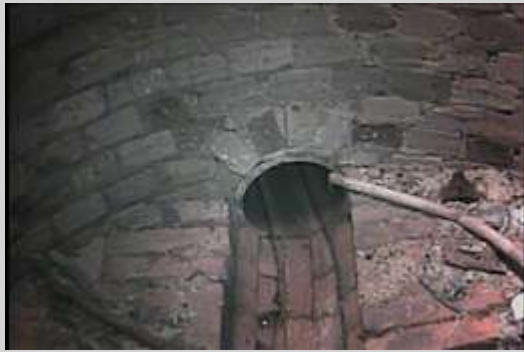
6 O'Clock Inflow

Pipe Height: **8.4** (in.) Rod and Bar (Angled)

Invert Depth: **8.56** (ft.) Flow Characteristics: **Slow**

Infiltration: **None** Pipe Seal Cond: **Sound**

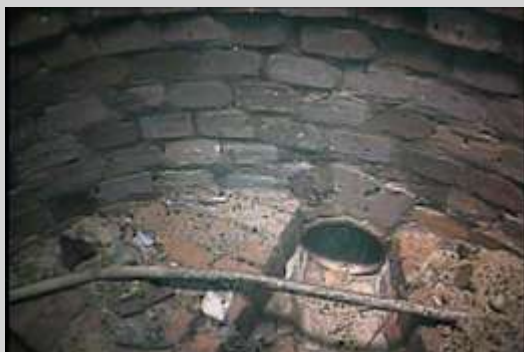
9 O'Clock Inflow

Pipe Height: **6** (in.) Rod and Bar (Angled)

Invert Depth: **8.48** (ft.) Flow Characteristics: **None**

Infiltration: **None** Pipe Seal Cond: **Sound**
